Appendix B
Photograph Log and Photographs

Super Salvage, Inc.
Industrial Stormwater Inspection Report

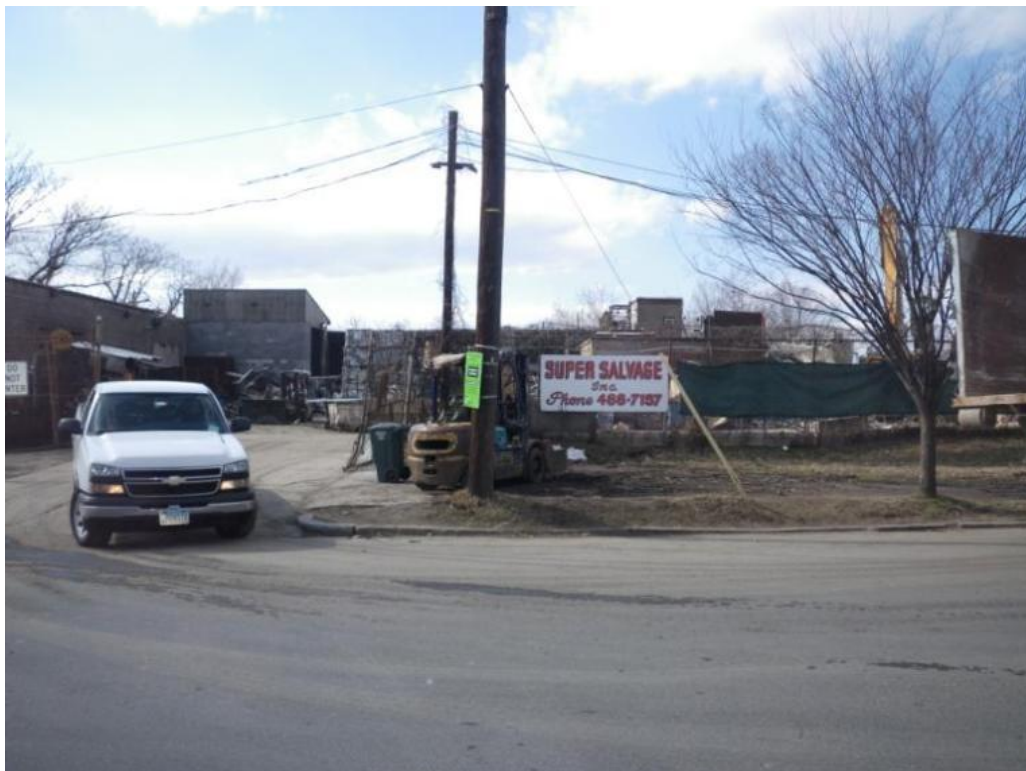
Photograph 1. Facility sign and vehicle track out at Entrance 1.

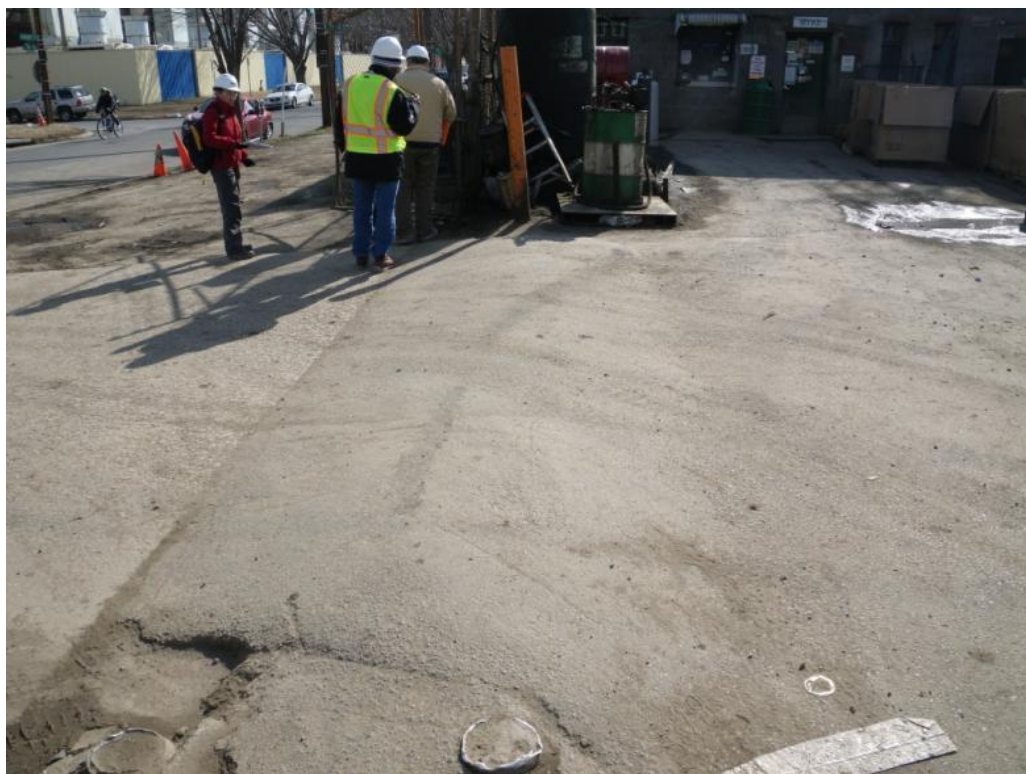
Photograph 2. Berm at Entrance 1 of the site.

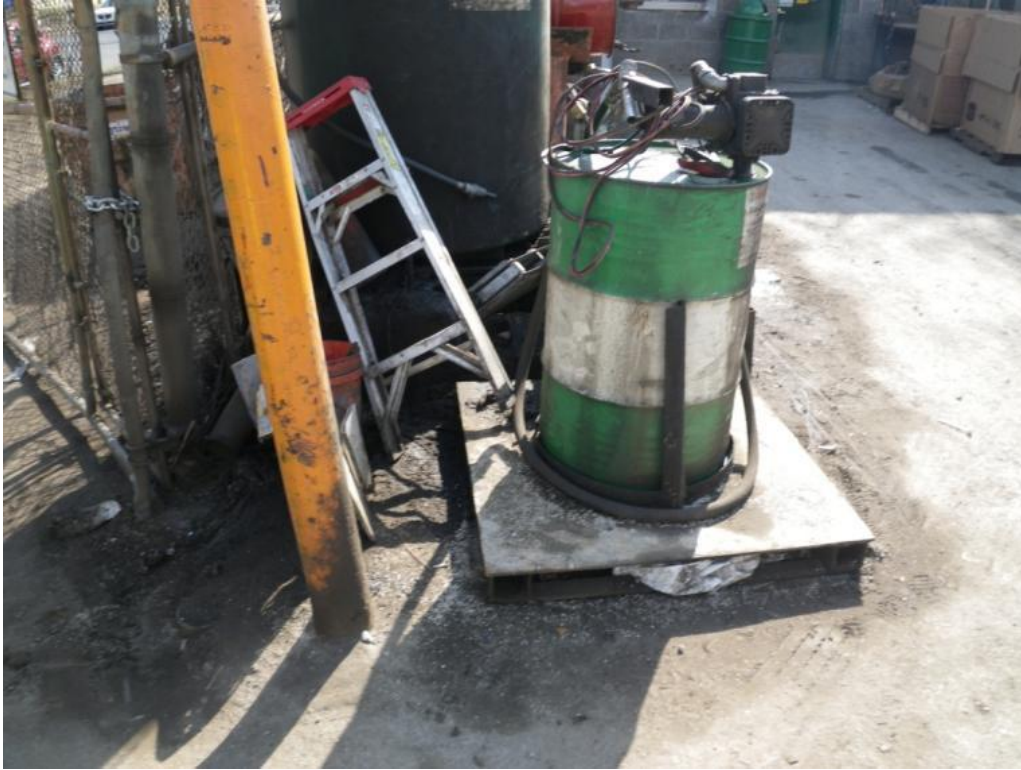
Photograph 3. **Barrel on wooden pallets at Entrance 1 of the site.**

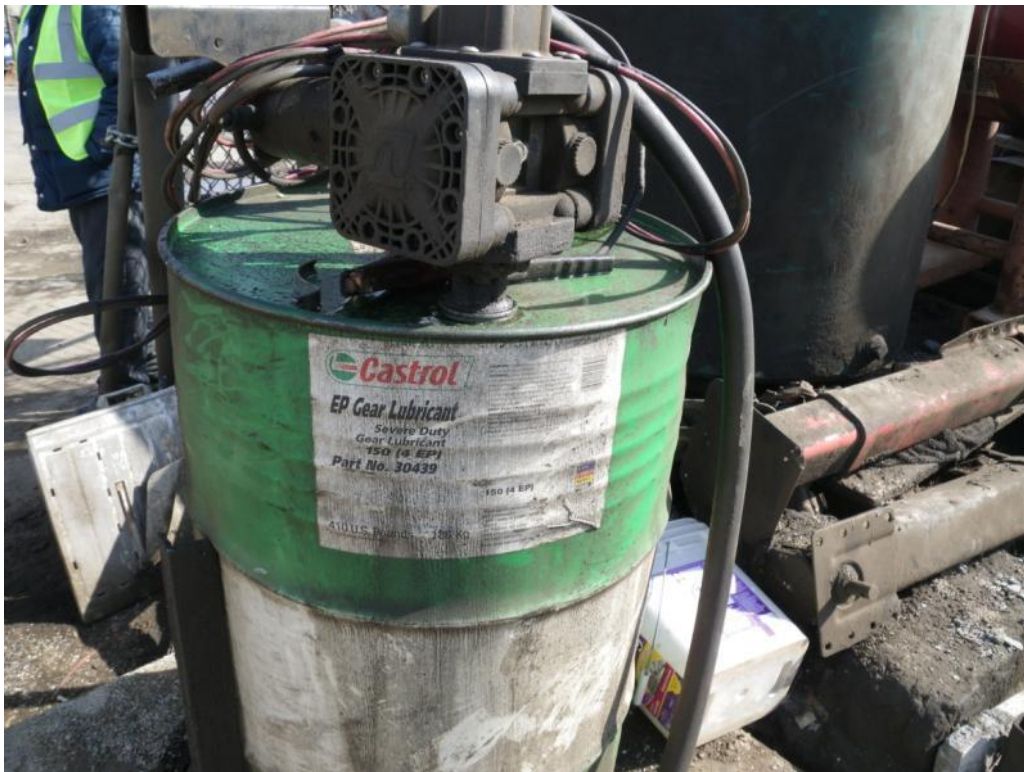
Photograph 4. **Close up view of the lubricant label on the barrel in Photograph 3.**

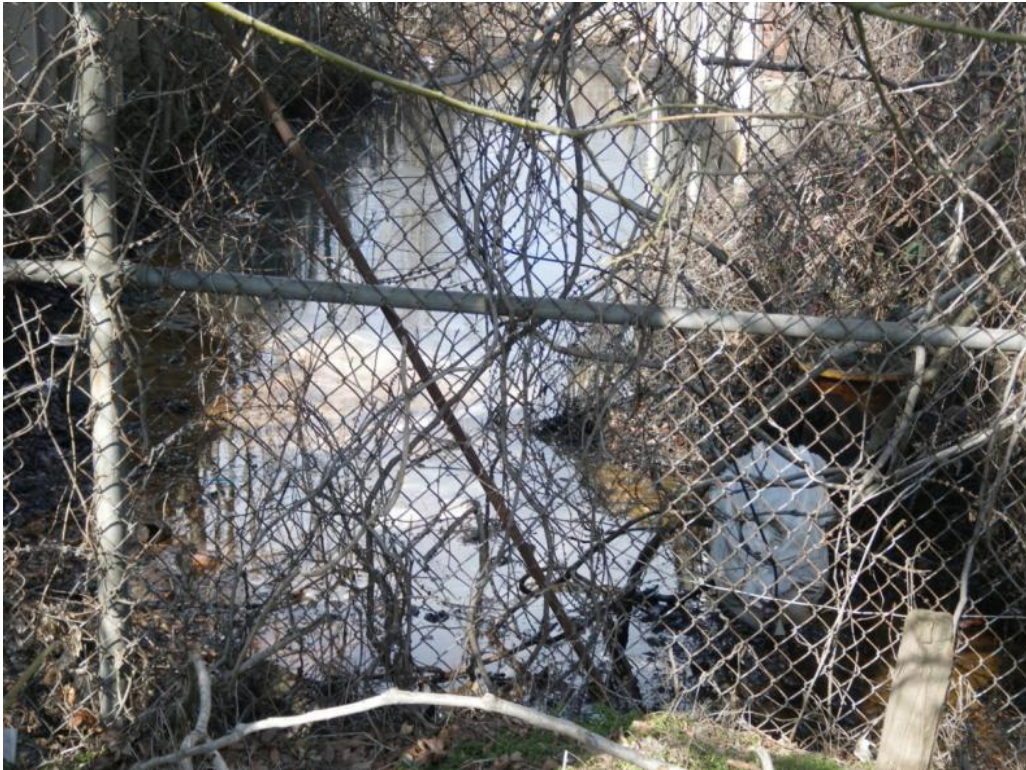
Photograph 5. Overall view of the large runoff collection pond.

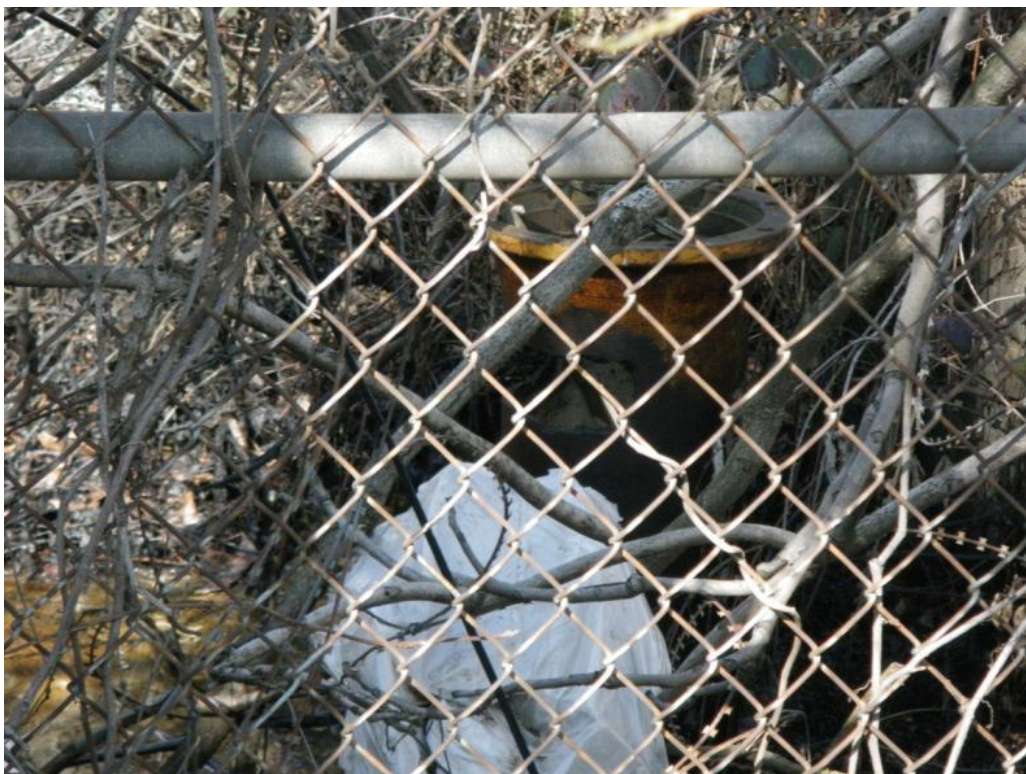
Photograph 6. The riser in the large runoff collection pond.

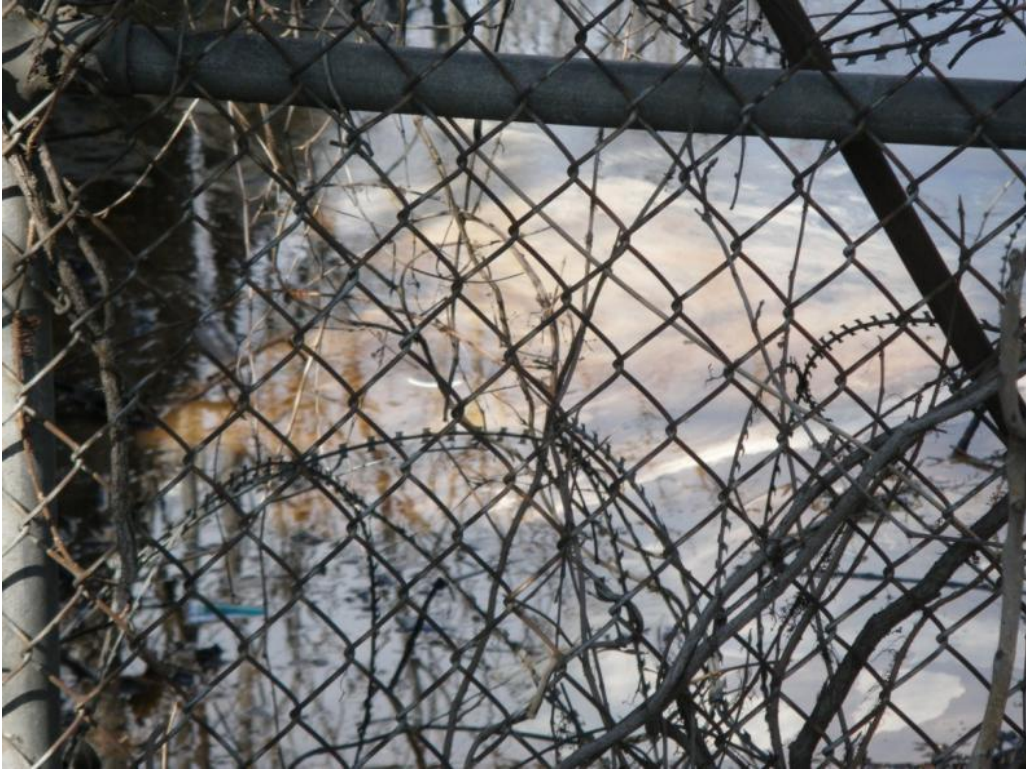
Photograph 7. Close up view of the sheen on the large runoff collection pond.

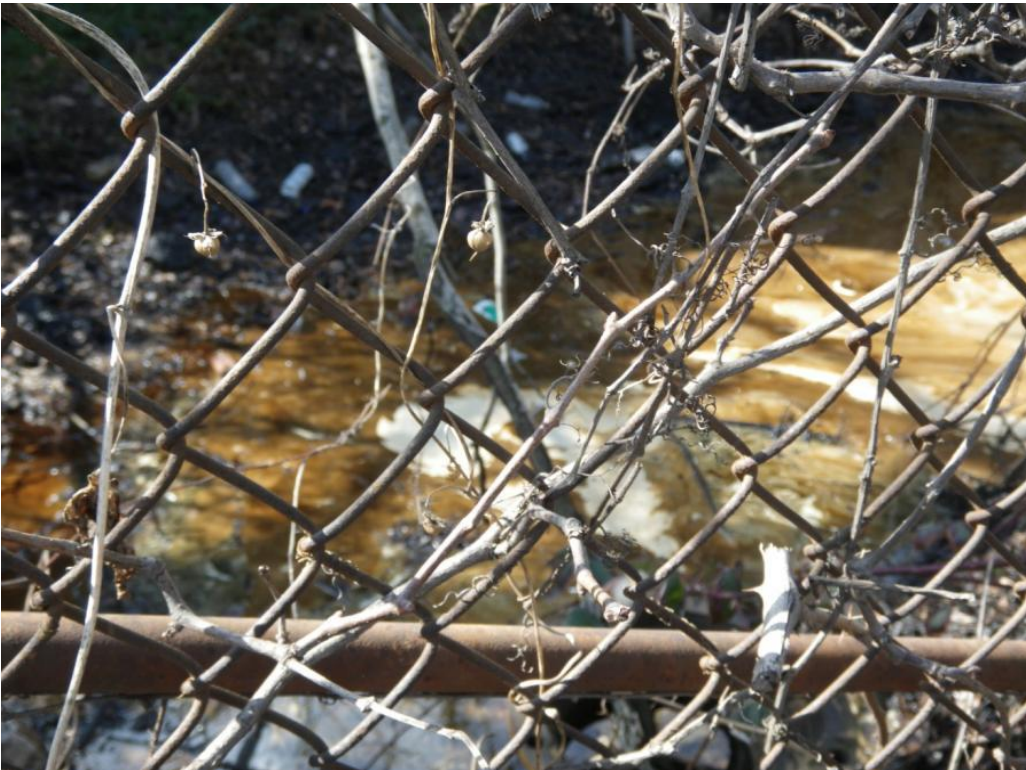
Photograph 8. Alternate view of the sheen on the large runoff collection pond.

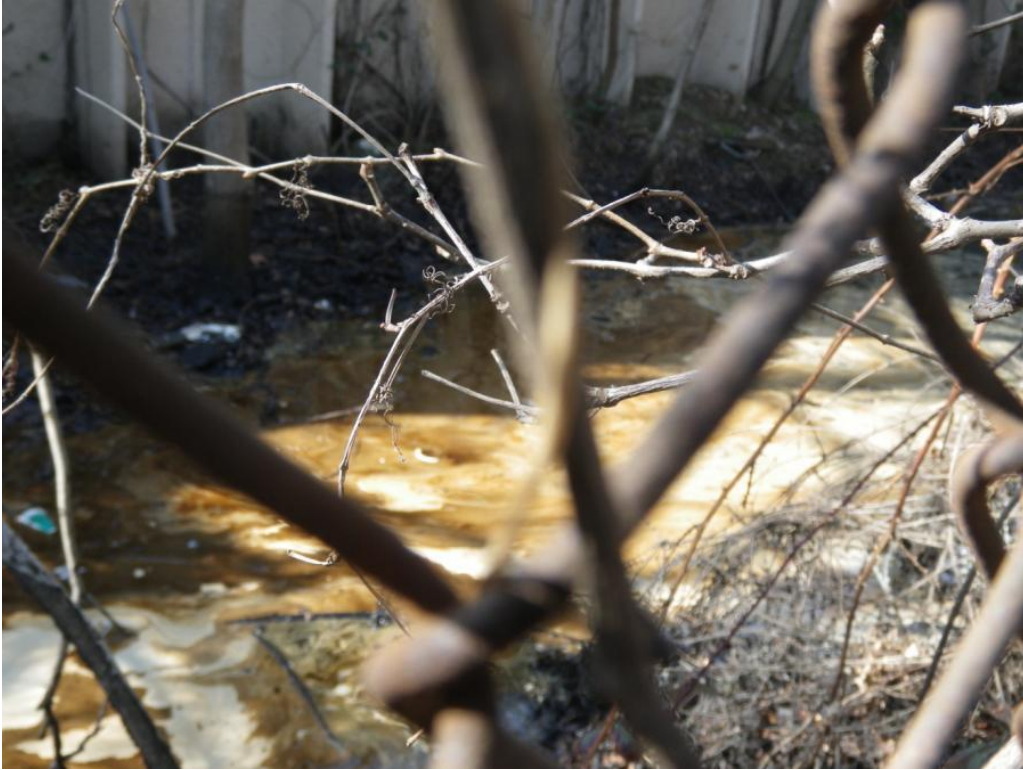
Photograph 9. **View of the sheen on the large runoff collection pond.**

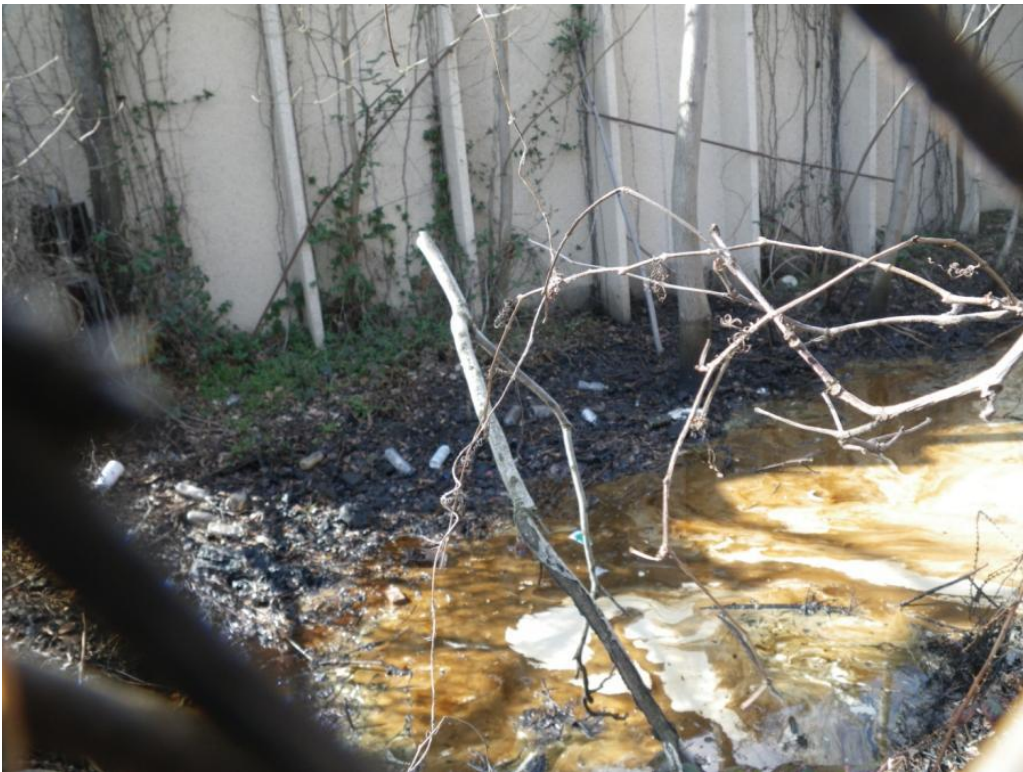
Photograph 10. **View of the sheen on the large runoff collection pond.**

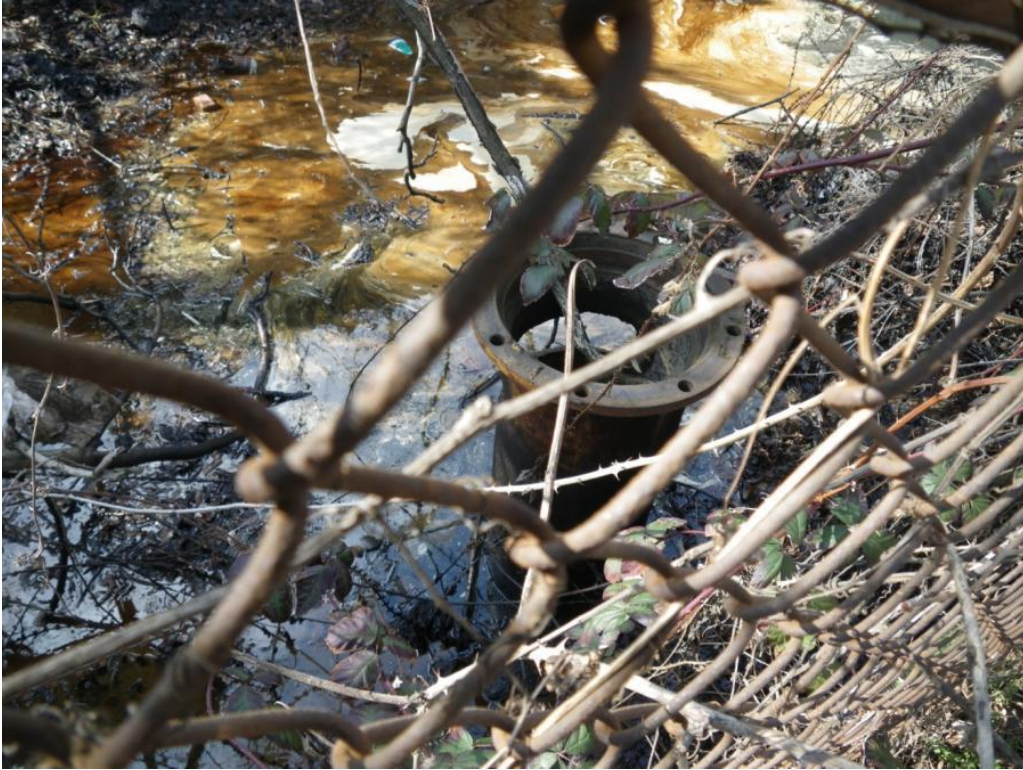
Photograph 11. View of the sheen on the large runoff collection pond with the riser.

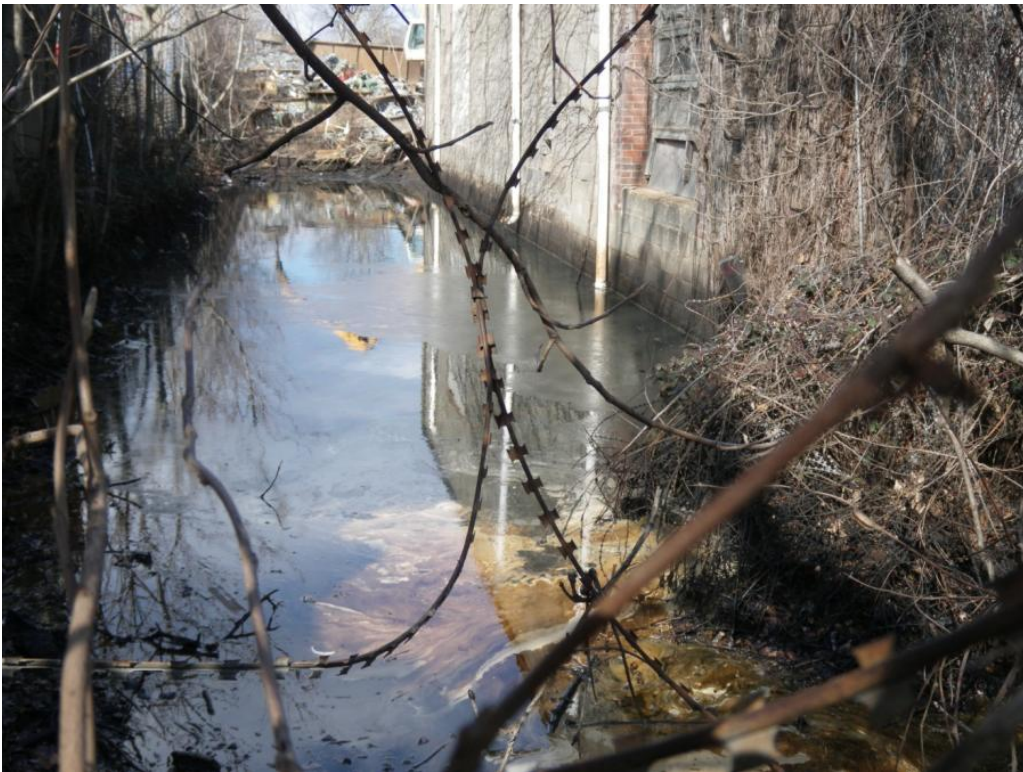
Photograph 12. The water elevation line height as indicated on side of the building.

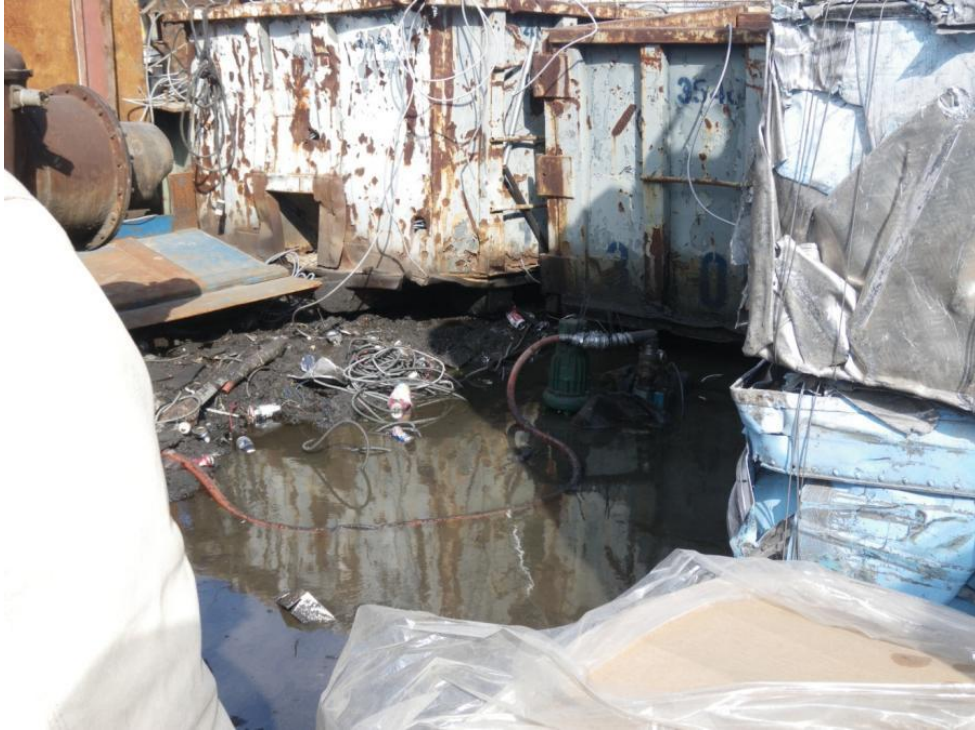
Photograph 13. Small runoff collection pond with a manual pump near the center of the scrap yard.

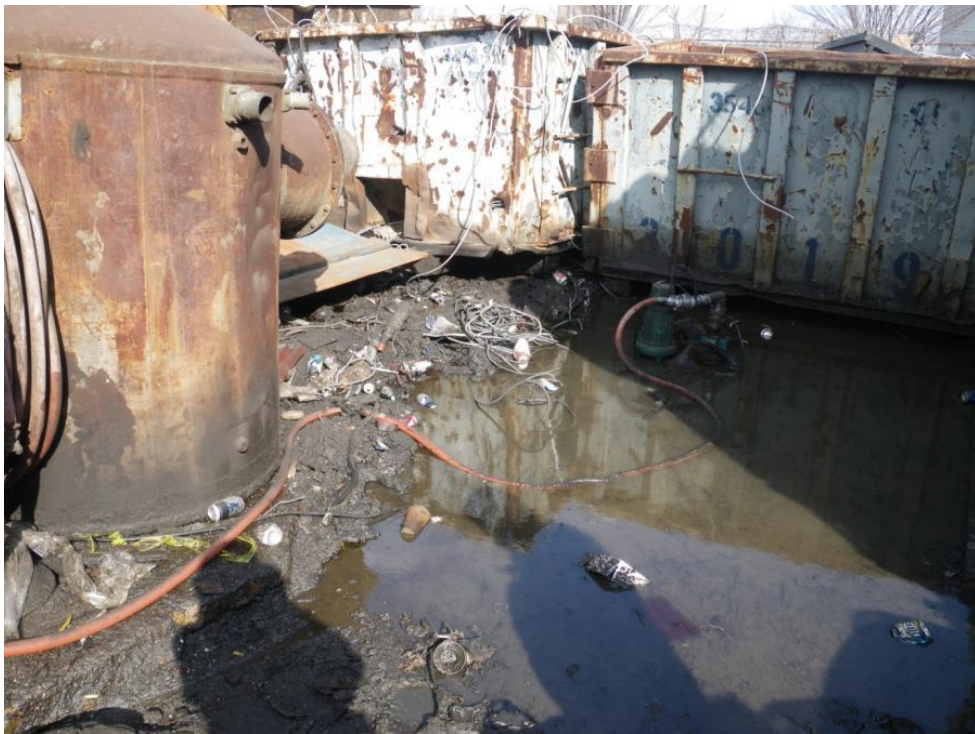
Photograph 14. Alternate view of the small runoff collection pond with the manual pump.

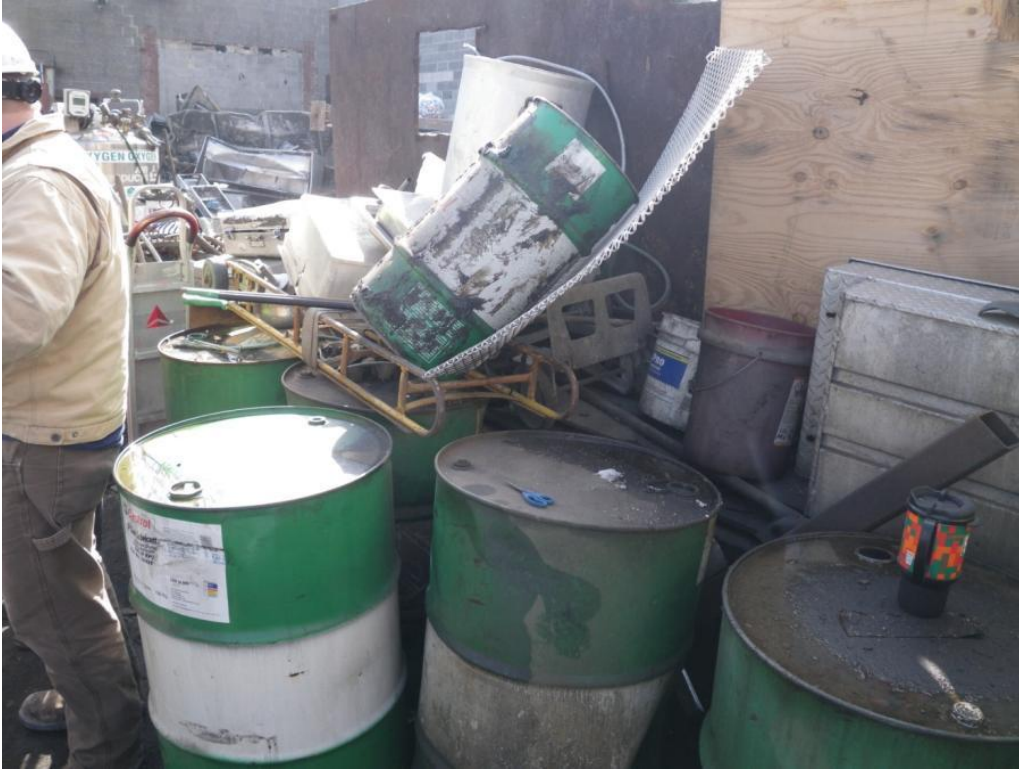
Photograph 15. Storage of drums adjacent to small runoff collection pond.

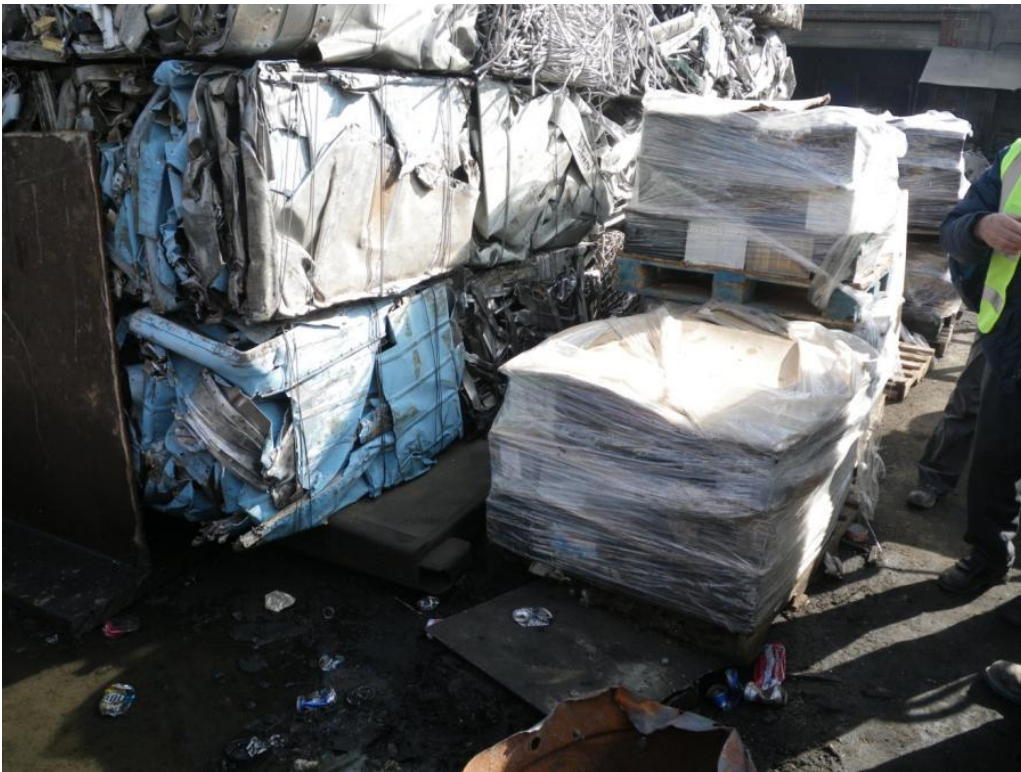
Photograph 16. Pallets of used car batteries adjacent to small runoff collection pond.

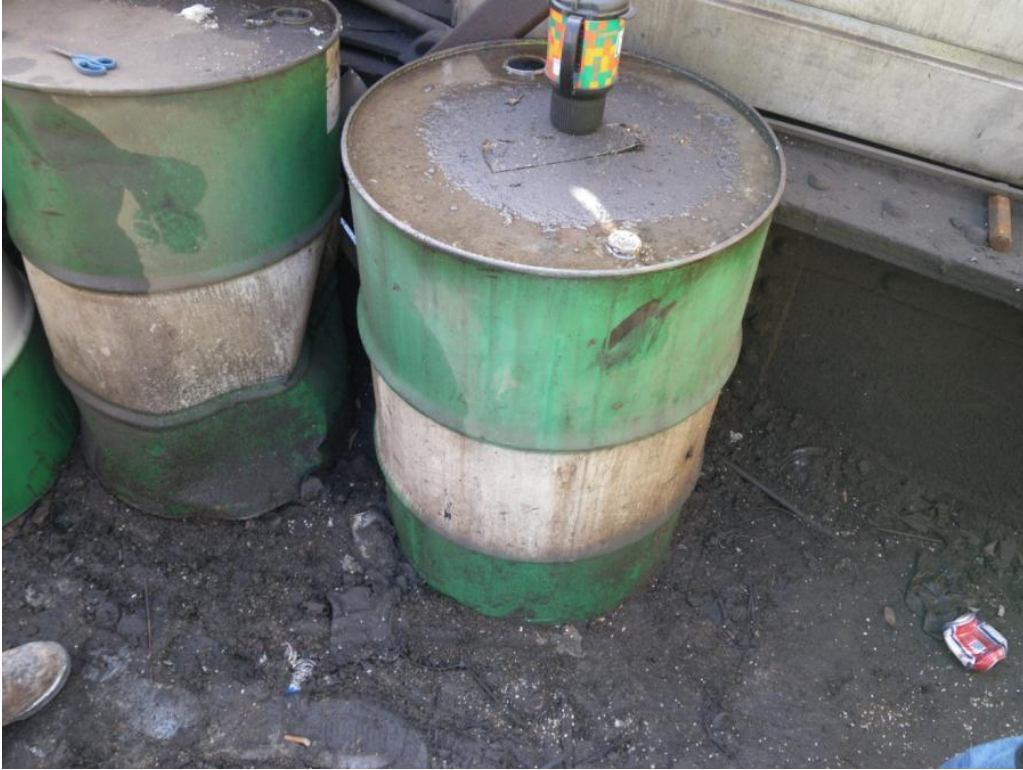
Photograph 17. Alternate view of drums with what appeared to be oil staining.

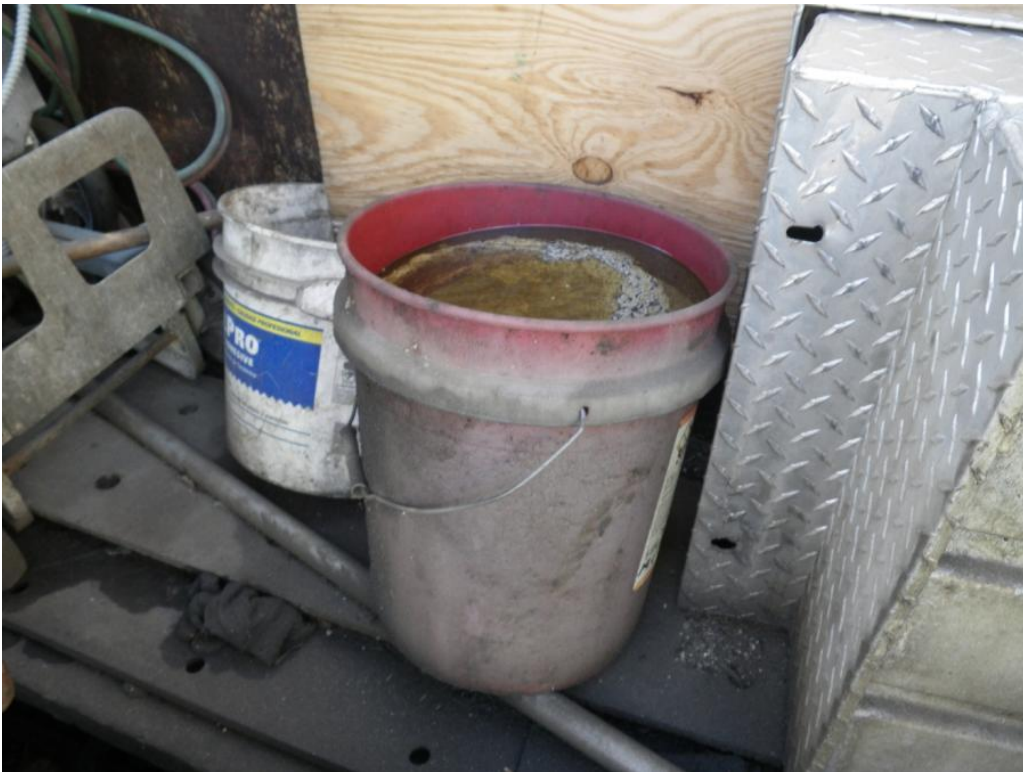
Photograph 18. Close-up view of an open bucket also visible in Photograph 16.

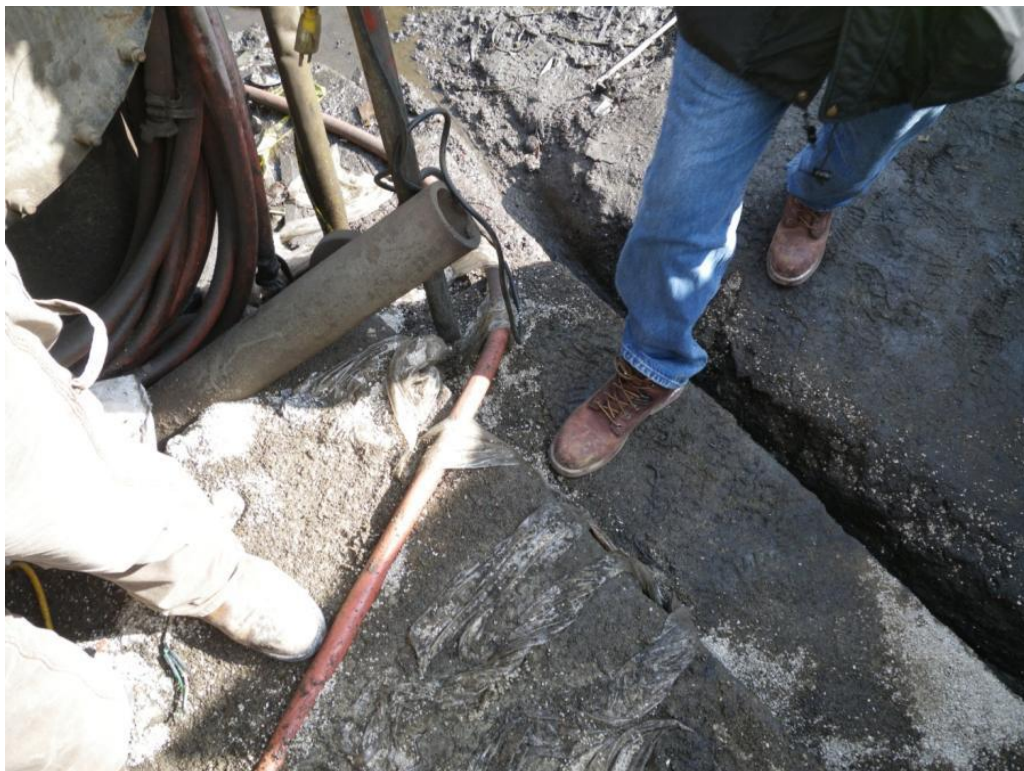
Photograph 19. Trench leading to the small runoff collection pond.

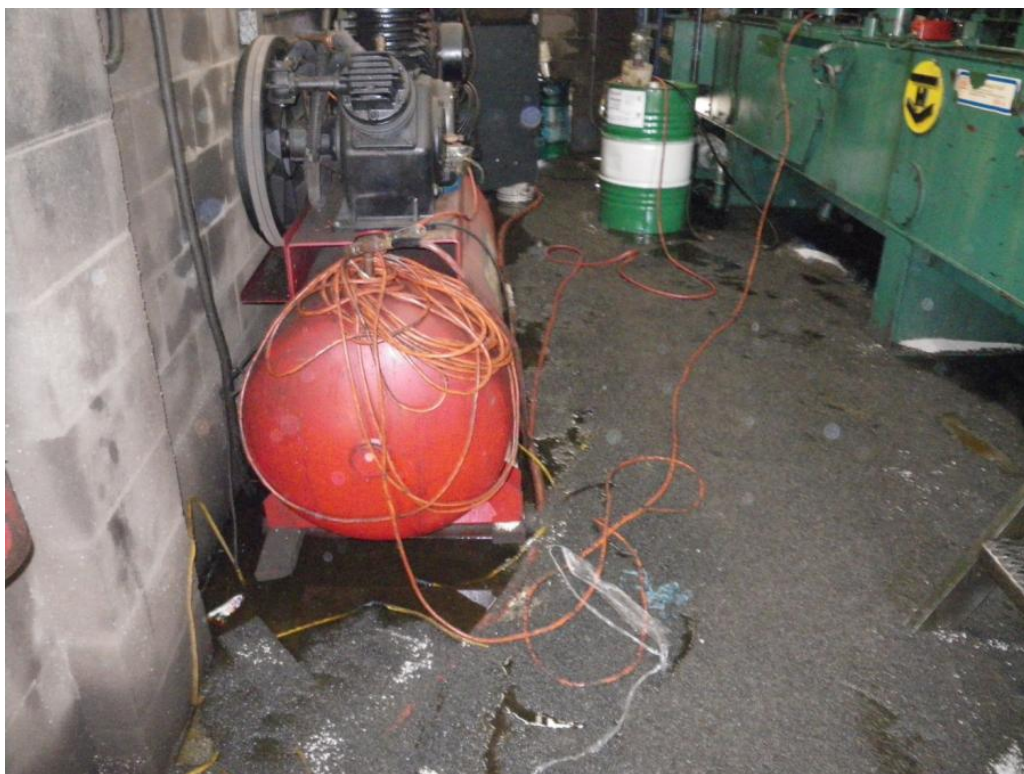
Photograph 20. Pooled fluids and saturated absorbent materials.

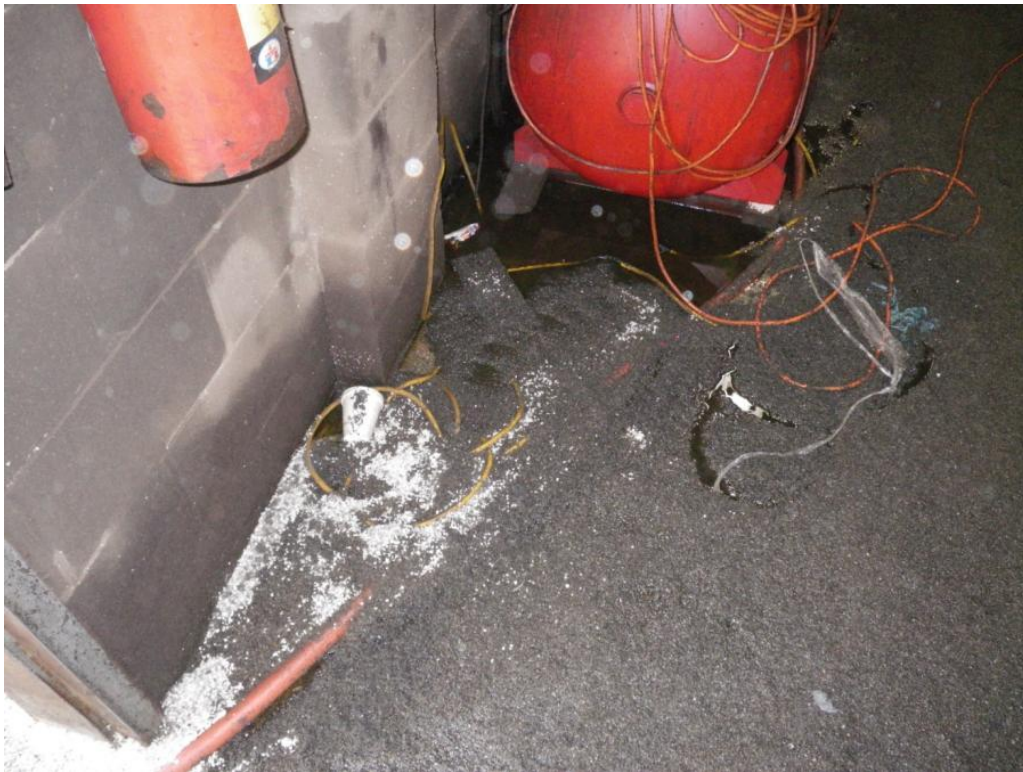
Photograph 21. **Alternate view of Photograph 20.**

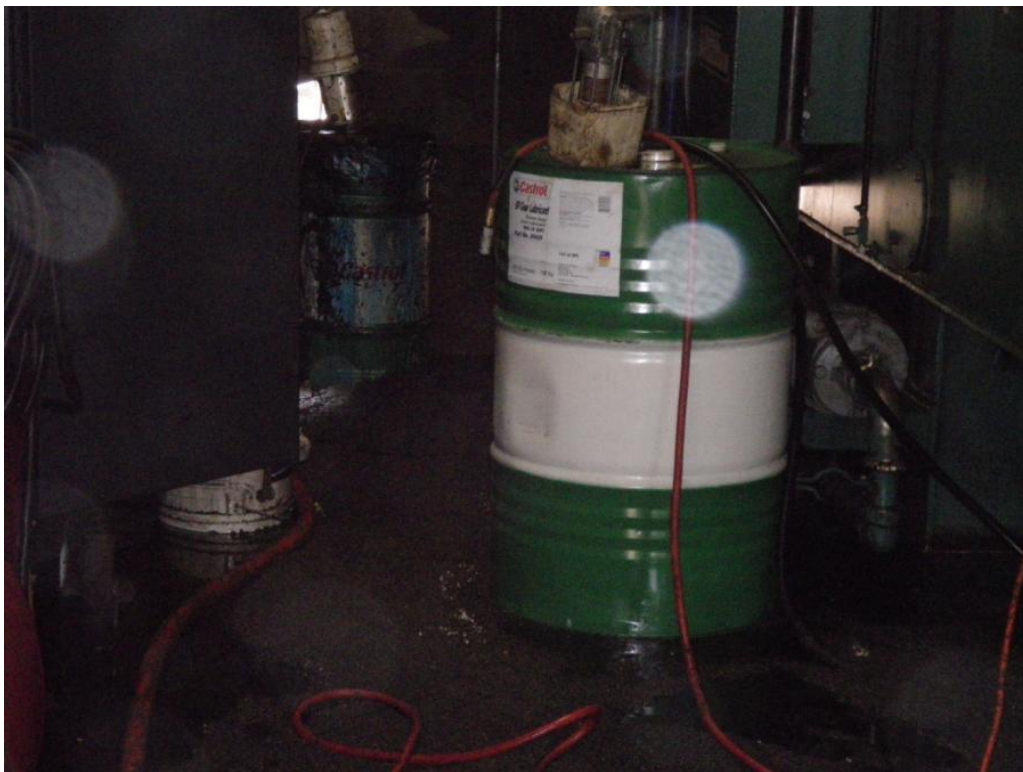
Photograph 22. **Close-up of two tanks in the building leaking onto the floor.**

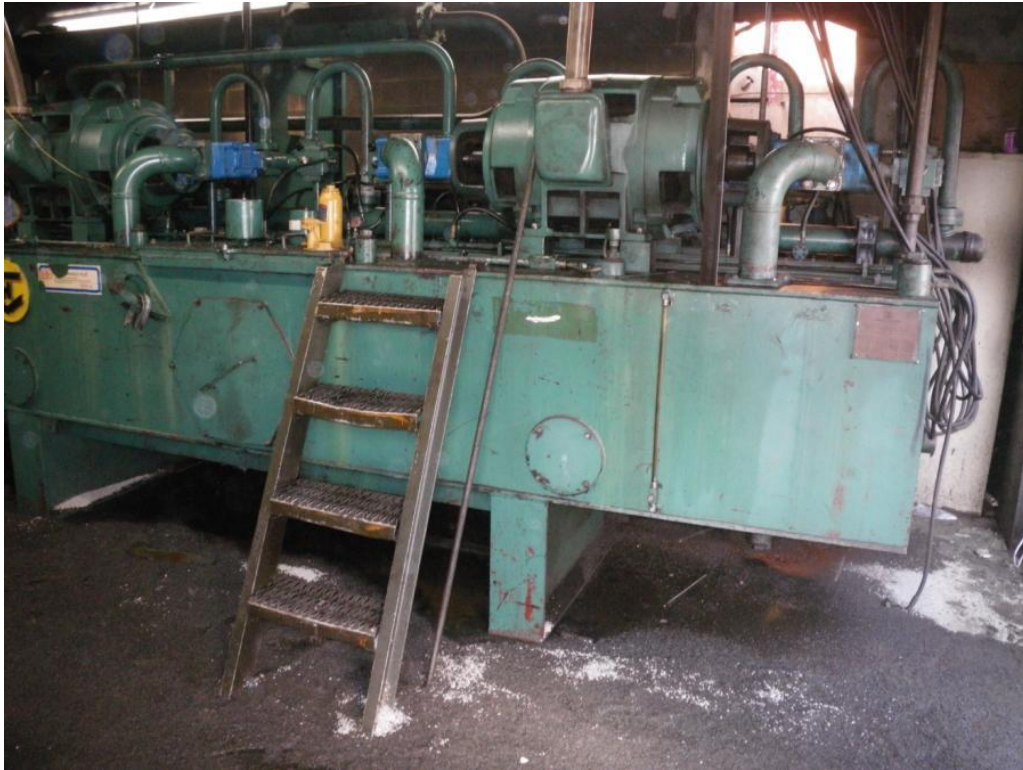
Photograph 23. **Hydraulic machinery with what appears to be oil underneath.**

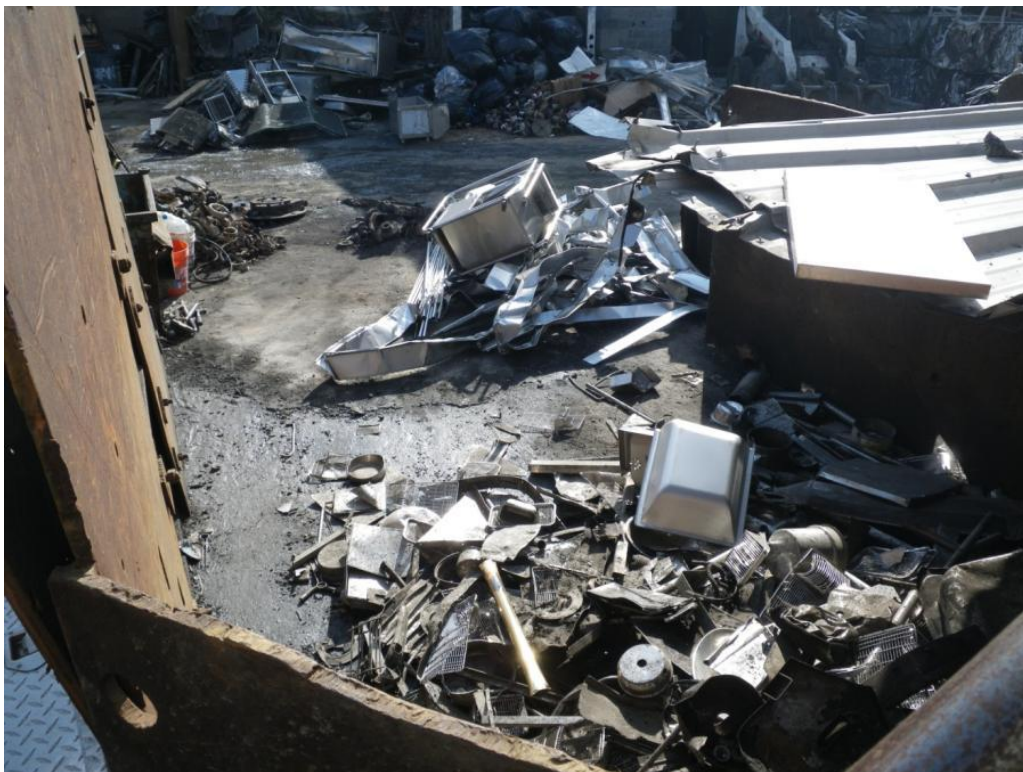
Photograph 24. **Debris from metal separation.**

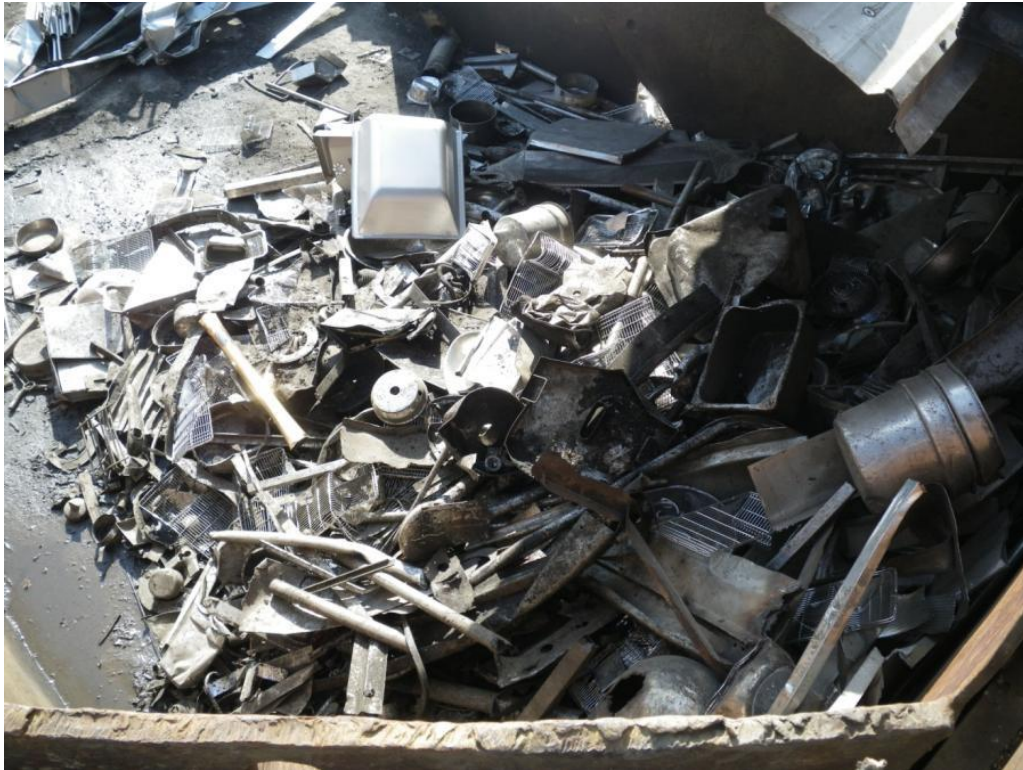
Photograph 25. **Alternate view of the debris including fluid pooling to the left.**

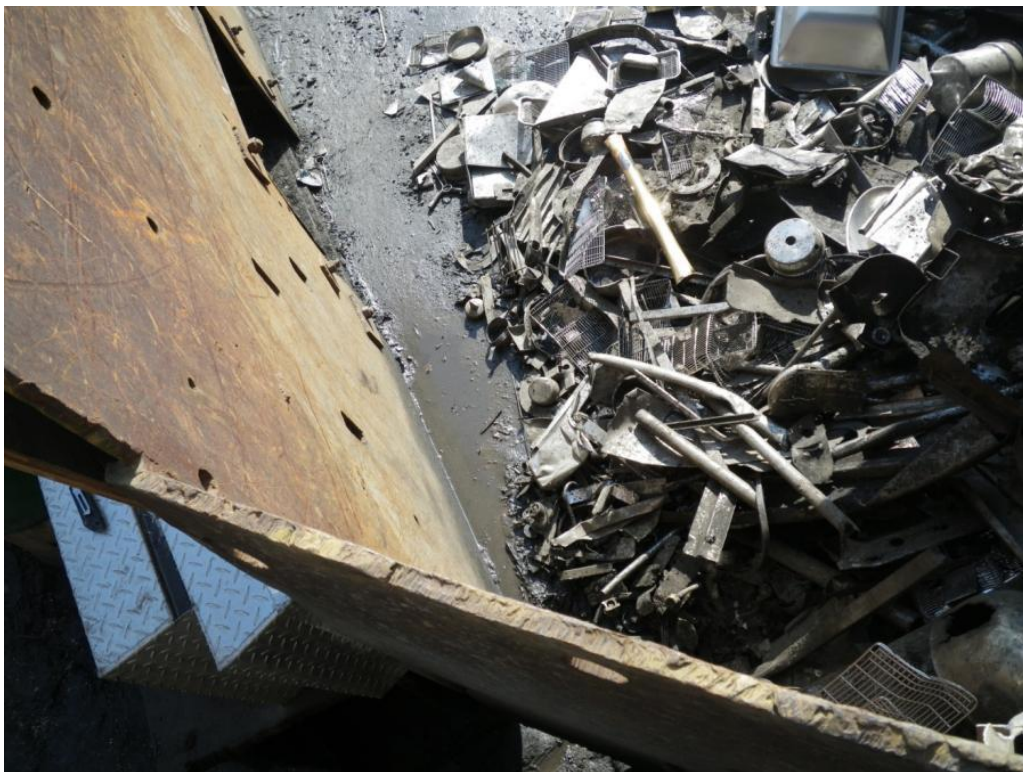
Photograph 26. **Alternate view of the fluid pooling towards the trench.**

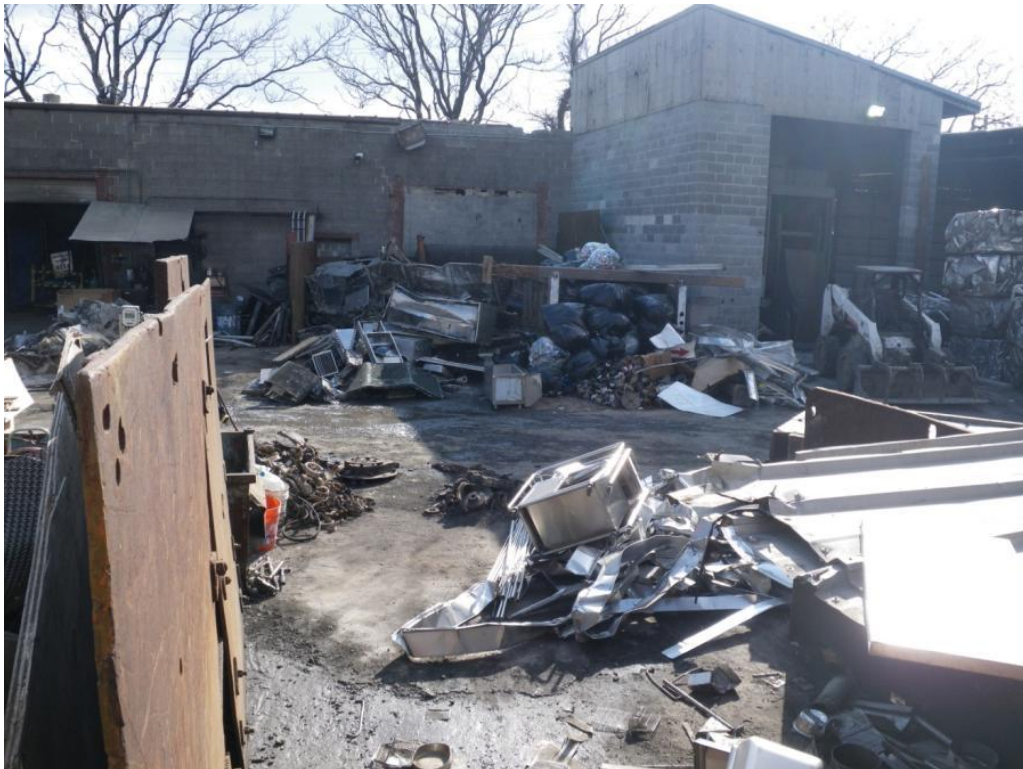
Photograph 27. Overall view of the facility from the roof of the scrap bay.

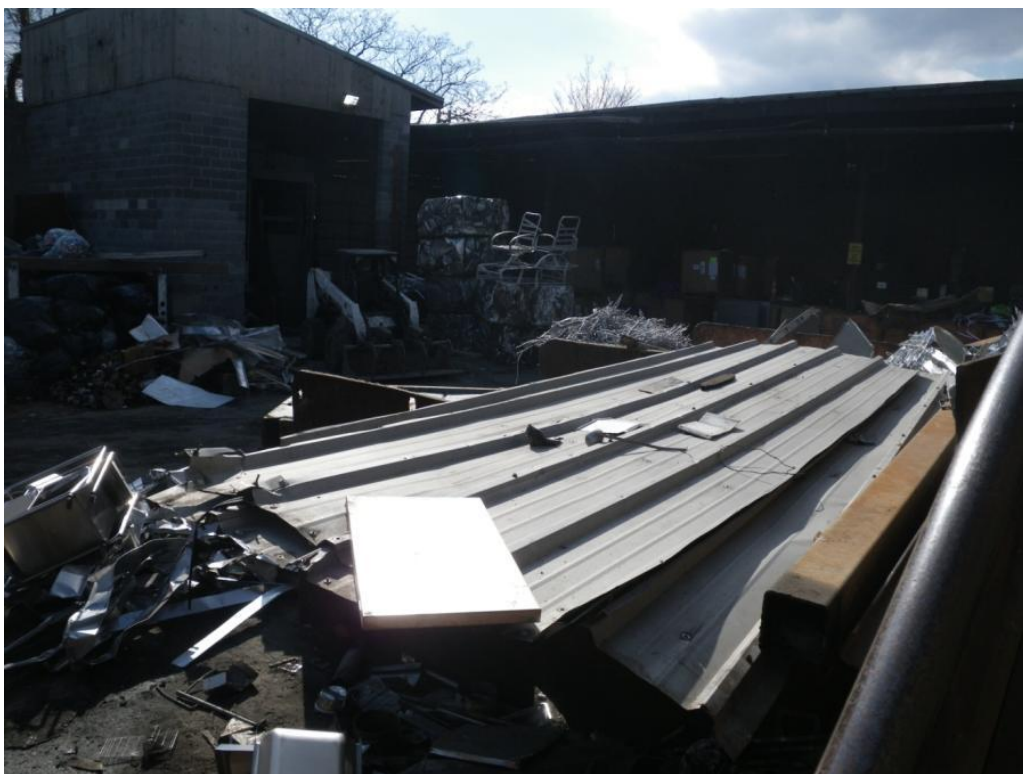
Photograph 28. Another overall view of the facility.

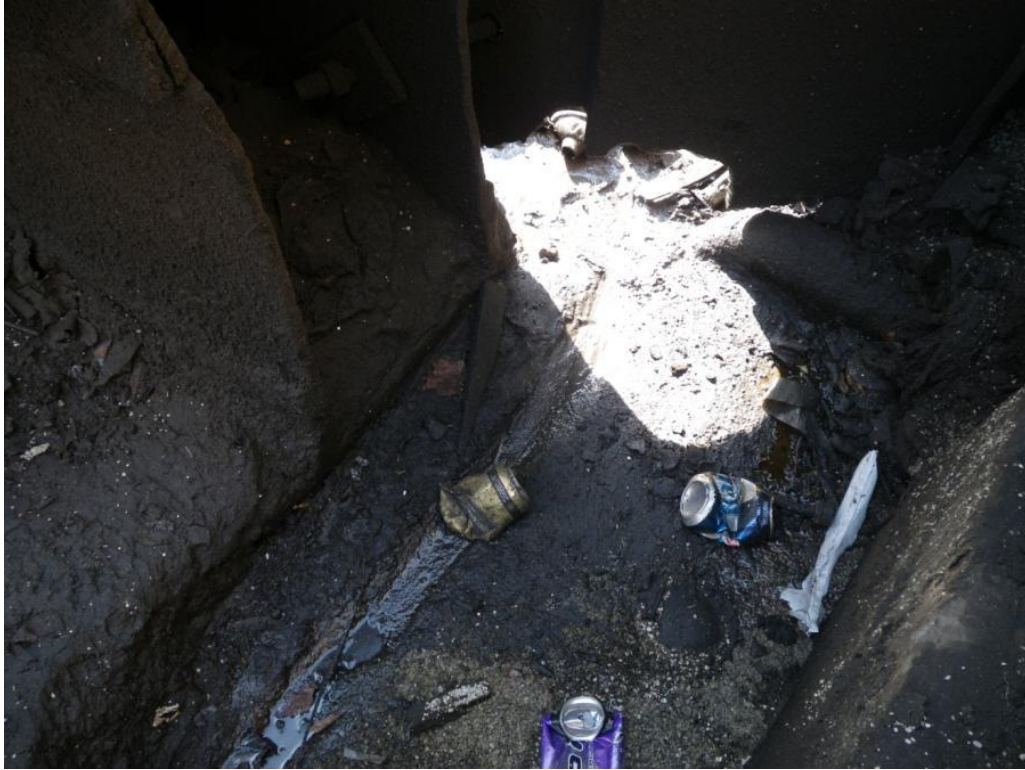
Photograph 29. Entrance to the trench.
